CONFIDENTIAL INSPECTION REPORT

INSPECTION DATE

2/16/2013 9:00 am to 12:30 pm

SUMMARY REPORT

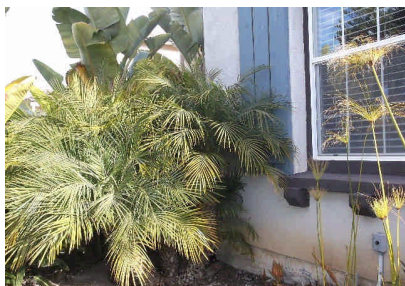
Vegetation is encroaching on the structure, and should be kept a minimum of eight inches away for the general welfare of the walls and foundation.

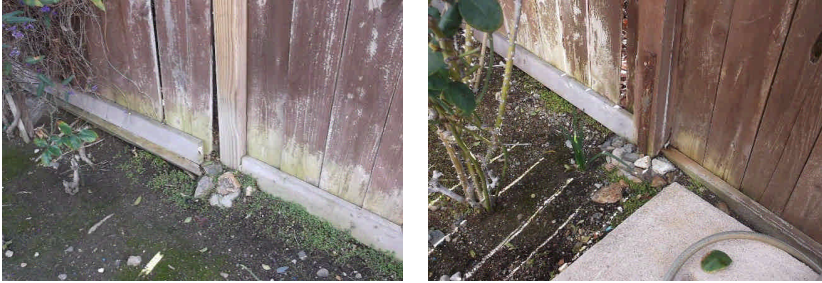
The fences and gates are serviceable, but wooden portions have damage commensurate with their age and regular maintenance would be prudent..

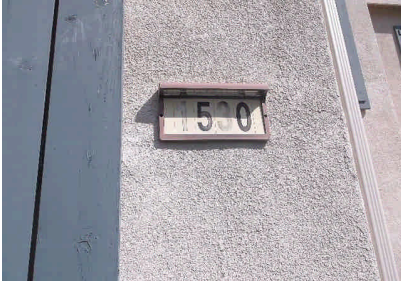
The house numbers on the front porch are incomplete.. We routinely recommend the full address be readable from the street..

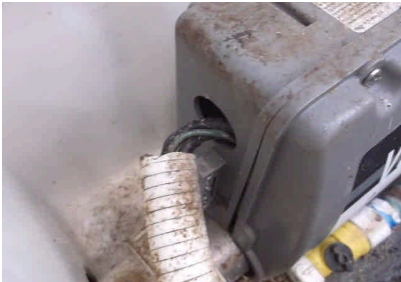
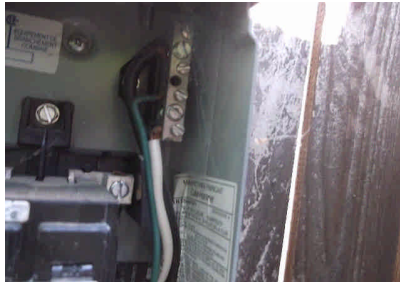
Portable Spa

- Portable spa is in need of service or repairs

The portable spa was not tested because there is no water in the unit. There is evidence of rodent activity in the enclosure. Rodents can damage the hoses, and wiring.. Furthermore the system is wired with three feed wires, and there is no ground wire feed from the panel. No clamp noted at panel connection in enclosure. Unit should be evaluated by a Spa Technician.

Spas are dangerous due to possible child intrusion and drowning. Yard should conform to local child safety requirements. (This IS NOT a yard safety inspection)

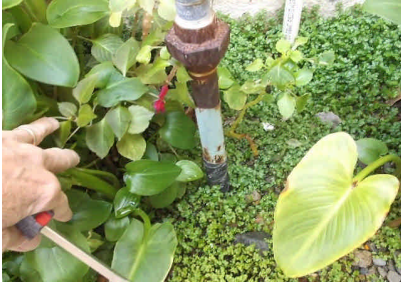
Rust and corrosion noted at added gas line - *Continued*

- Rust and corrosion noted at added gas line

There is rust and corrosion on the added gas line near the gas meter in the side yard.. Recommend evaluation by a Licensed C36 Plumbing Contractor..

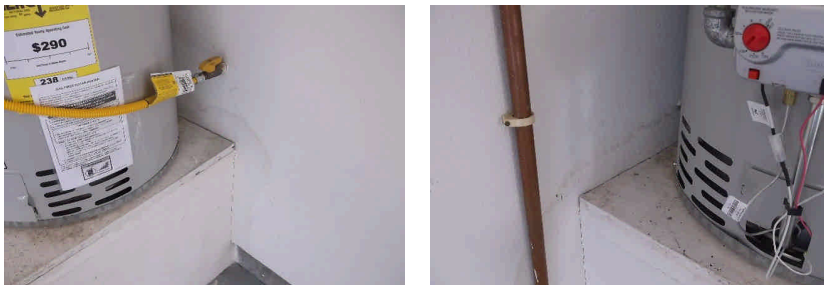
There is some evidence of past leakage on the water heater base in the garage.. We routinely recommend a

consultation with the seller to confirm that proper repairs were made and/or that you confirm there is no hidden damage, or have it checked by a Contractor for hidden damage.

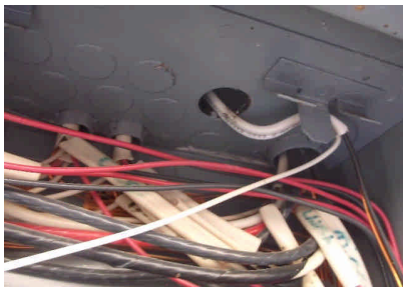
There are unprotected or unclamped wires passing through the panel - *Continued*

There are unprotected wire sets passing through the panel at the top. Wires should be clamped or the conduit should be properly secured where they pass through metal enclosures. Recommend evaluation by a Licensed Electrician.

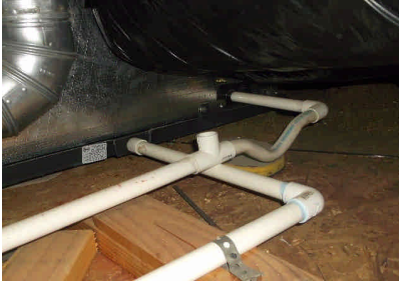
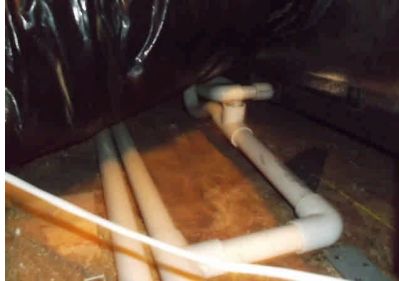
- No drain vent extensions noted on drain vents in attic

There is no extension pipes on the attic condensate drain pipe vents. These fitting could leak into the attic if the drains back up. Recommend that an extension be installed on the vent fitting. The vent extension is a piece of 3/4 inch schedule 40 PVC pipe about 5-7 inches long, or at least long enough to extend 2 inches above the primary drain port level.

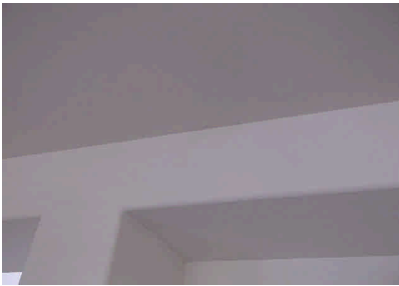
- There is a moisture stain on the family room ceiling

There is a moisture stain on the family room ceiling directly under the bathroom.. This does not appear to be a chronic leak, but you may want to consult with the seller to find out what happened.. If you are not able to determine what has happened, we routinely recommend evaluation by a qualified Contractor to open up the ceiling to check for hidden damage, and to make repairs if needed

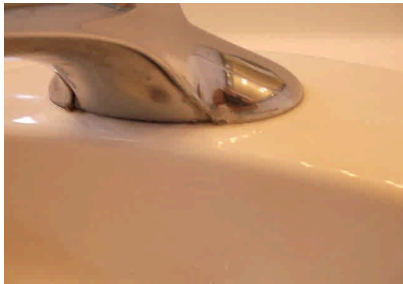
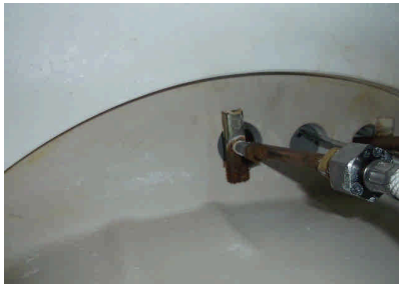
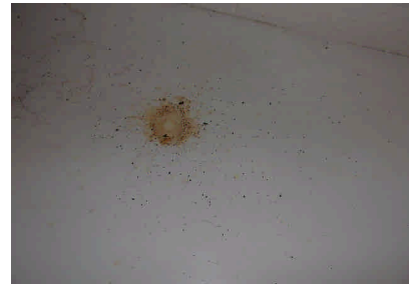
- The sink faucet leaks around the stem while in use

The sink faucet leaks around the stem while in use as evidenced by corrosion on the faucet, and rust on the connectors under the sink and it should be repaired/replaced.

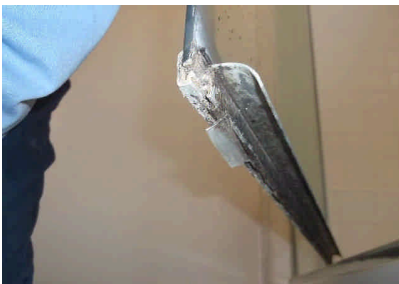
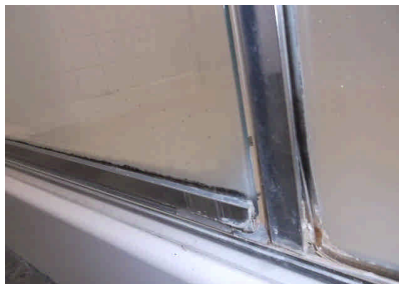
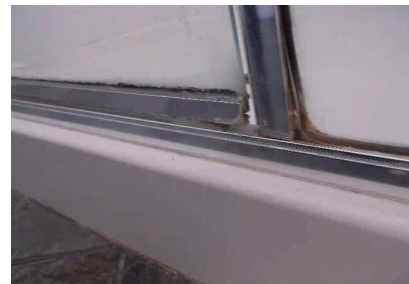
- Splash guard stripping missing or damaged
- Shower door does not fully shut

The splash strip is missing/damaged at the base of the shower door. We routinely recommend this strip be installed to prevent water from seeping under the shower door.

The master shower door does not fully latch closed. Recommend evaluation by a qualified C17 Glazing Contractor who is familiar with shower enclosure doors..

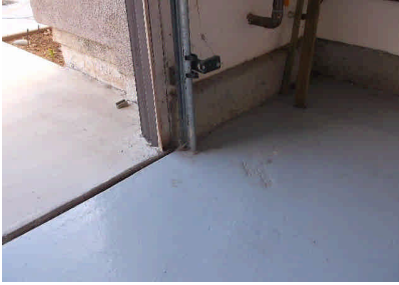
The infra red sensors are functional but located higher than the recommend six inches above grade - *Continued*

- The infra red sensors are functional but located higher than the recommend six inches above grade
